FLOODPLAIN HABITAT ASSESSMENT

ISD HOLLY STREET CAMPUS - CREEK BANK REPAIR ***CITY OF ISSAQUAH***

Wetland Resources, Inc. Project #21034

October 29, 2021

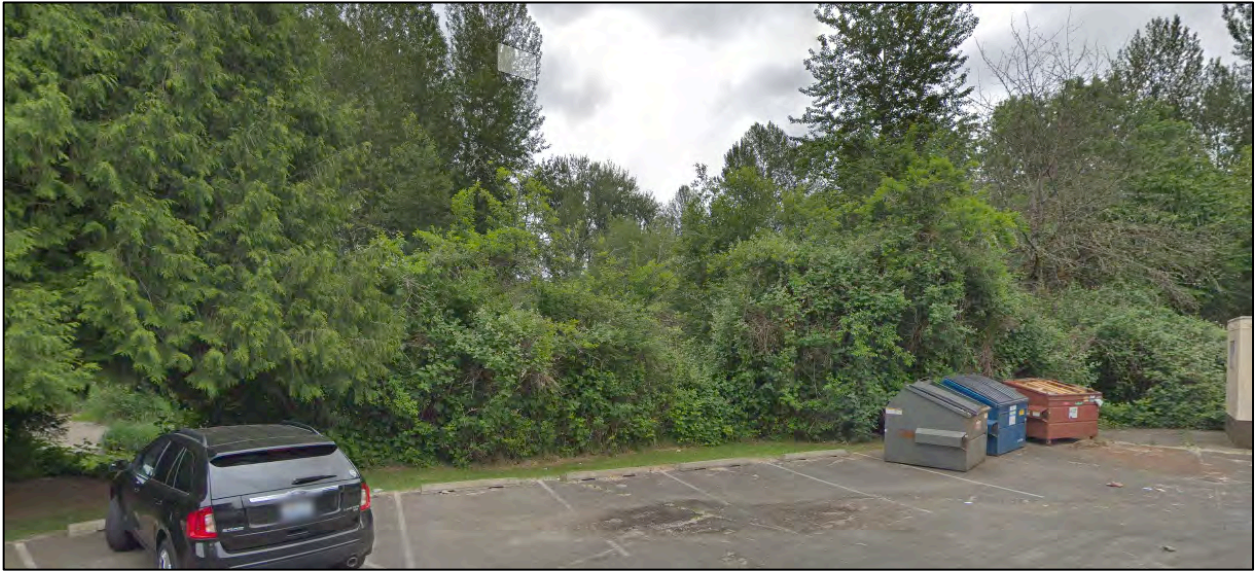
Figure 2 - Previous condition of bank prior to erosion event, May 2018 (Source: Google Maps).

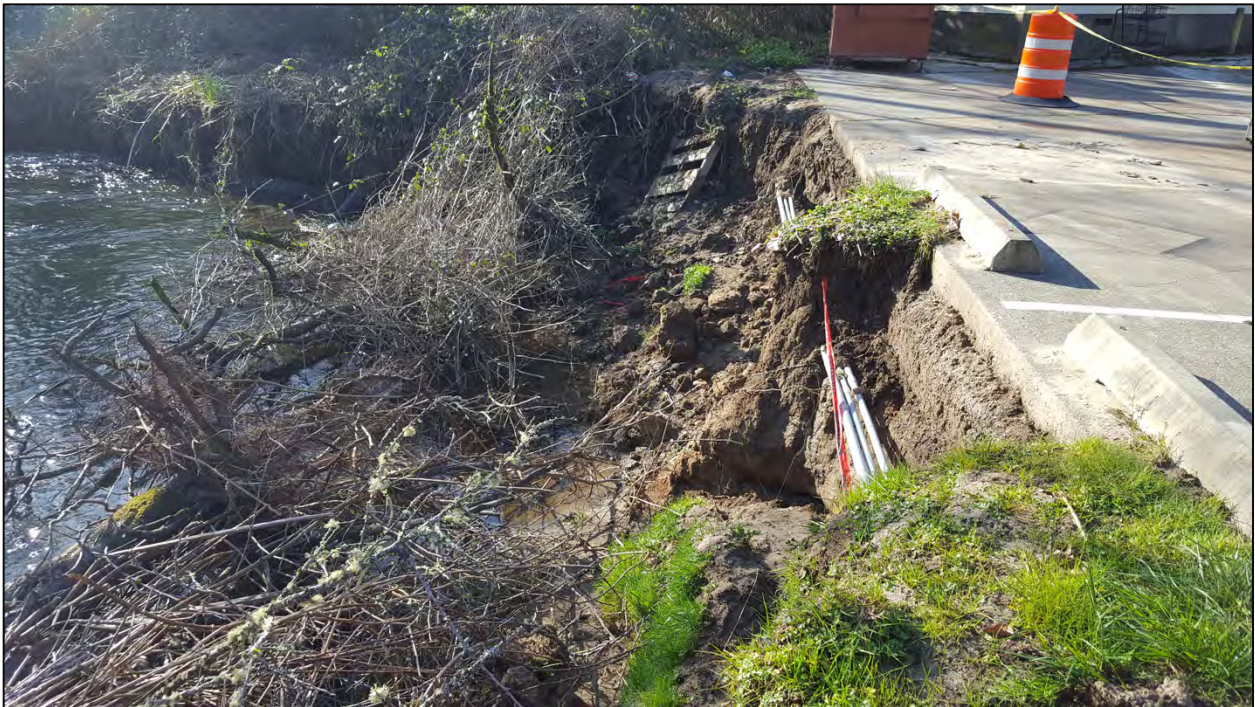
During the winter of 2019-2020, during periods of unusually heavy, prolonged rain, Issaquah Creek experienced extensive erosion of its west bank along the eastern boundary of the subject site.

Figure 3 - Extent of bank erosion of Issaquah Creek during the March 19, 2020 site visit.

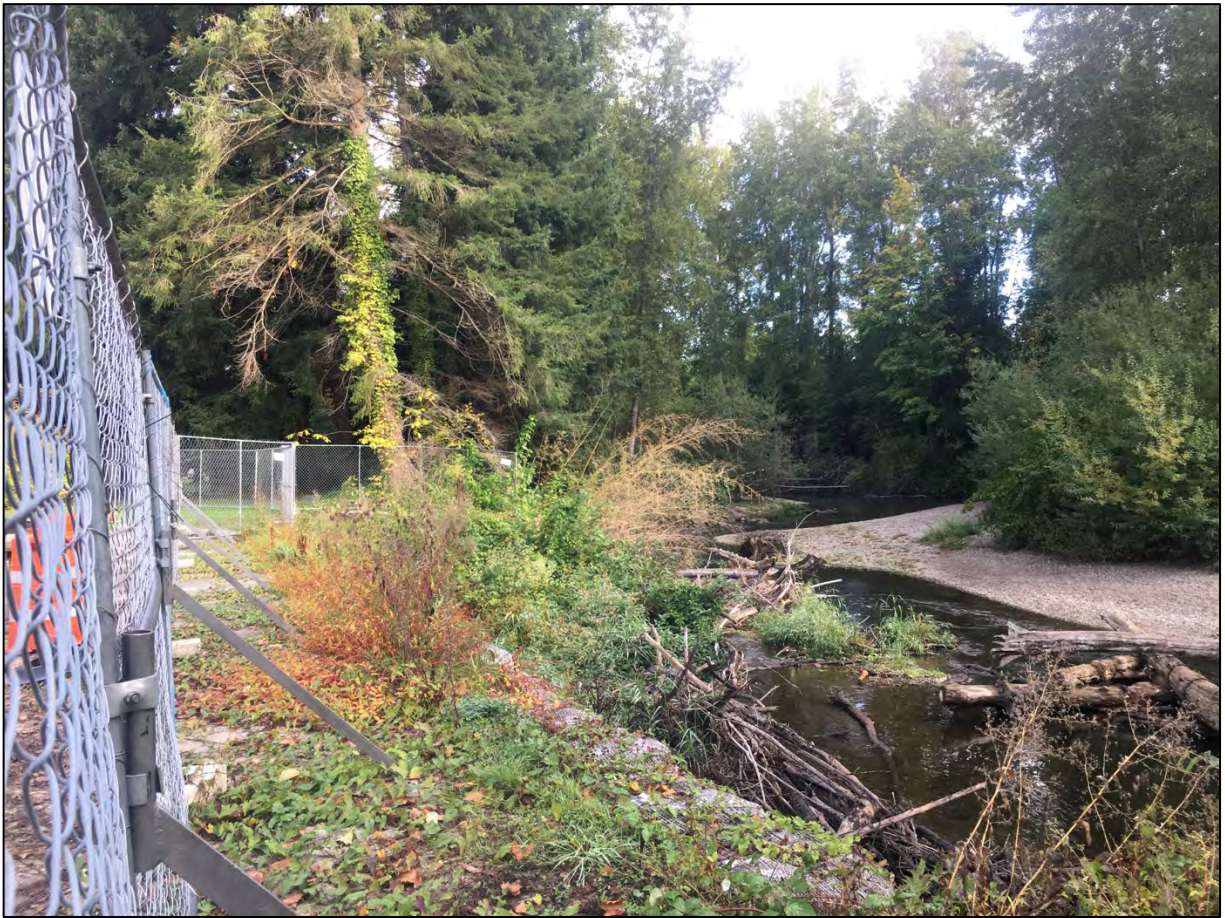
Figure 4 - Installed temporary bank stabilization measures and site conditions, facing northeast (October 8, 2021)

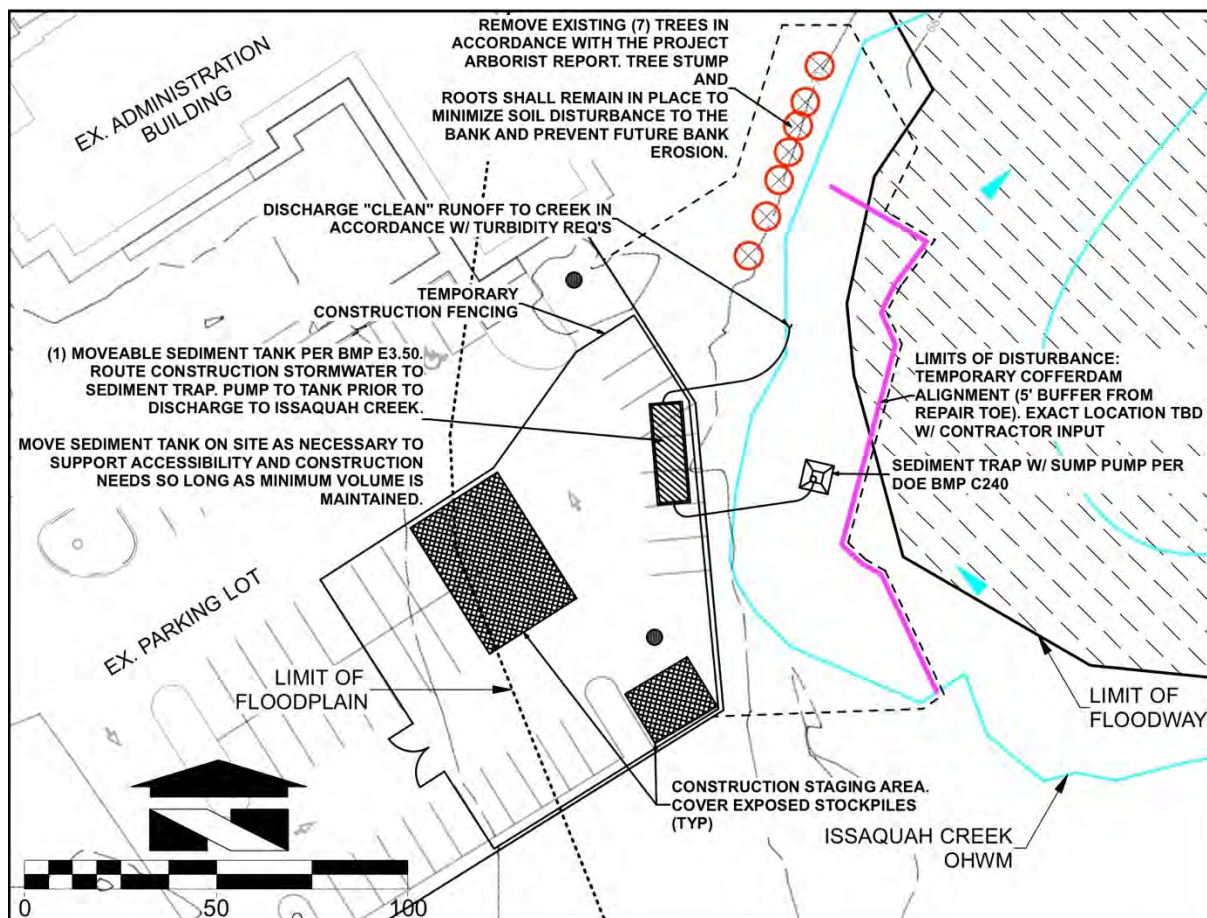
Figure 5 - Proposed Site Plan - Prior to Installation

A total of 8 hazard trees are proposed for removal along the streambank (see Appendix C). One tree has already been removed during installation of the temporary bank stabilization. Roots of the trees will remain in place to minimize soil disturbance and reduce further bank erosion. Removal of the trees will be mitigated for with restoration of the area with native shrubs and tree replacement in an area north of the work area. Trees are not proposed to be replaced within the same location as those removed, due to the proximity to the existing administration building and the potential hazard they would pose. Clearing limits are along the portions of the streambank where tree removal, and large-woody debris installation will occur (see Figure 5 below).

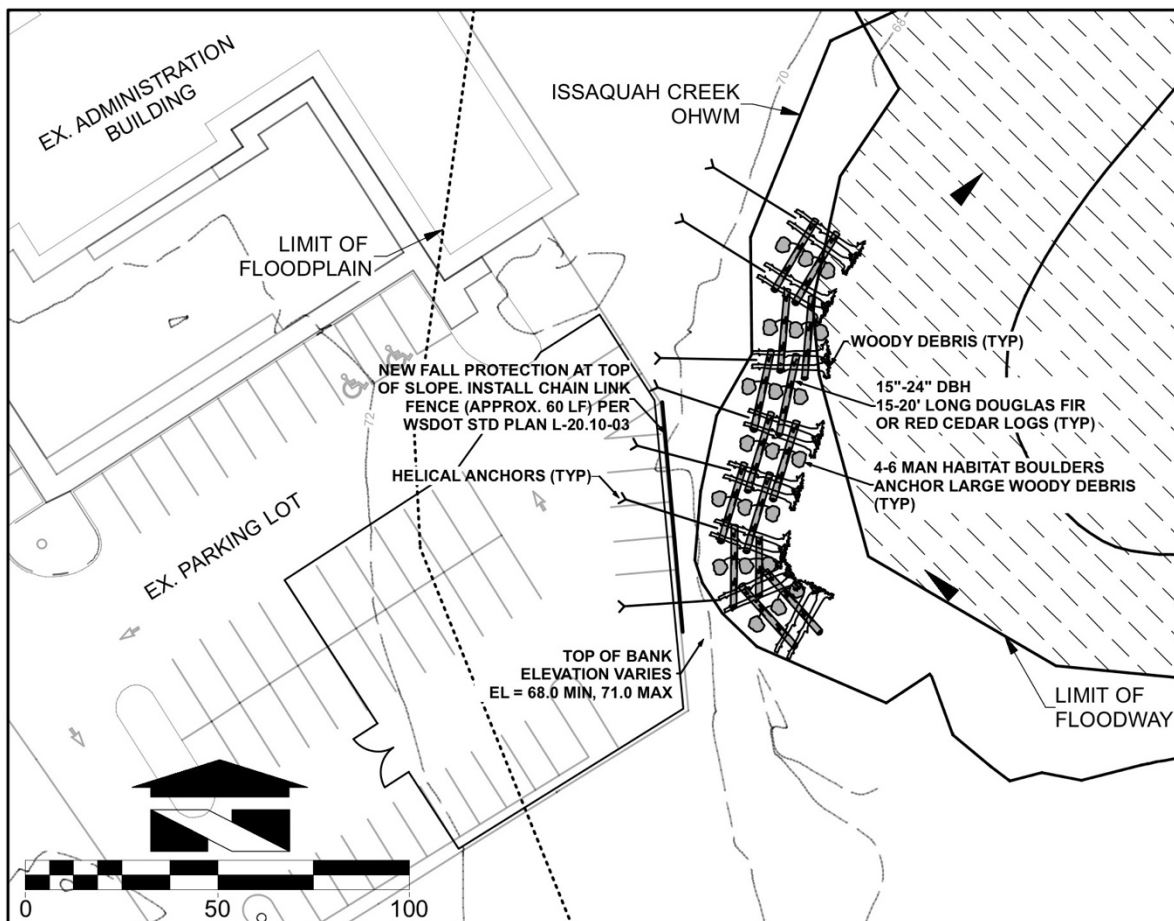
Figure 6 - Proposed Site Plan - Bank Stabilization

The permanent stabilization project will consist of installing streambank protection along approximately 130 feet of cutbank on the west side of Issaquah Creek. Protection will include reconstruction of a portion of the bank lost to channel erosion in proximity to Issaquah School District infrastructure with an engineered, non-deformable ‘log toe’ incorporating large woody debris and habitat boulders. The log toe will provide protection against the erosive forces directed toward the bank, and provide valuable fish habitat. Habitat boulders will anchor the large woody debris for normal and moderately-high flow flood stages of the stream. Mechanical anchors are included in the design as a supplemental security measure. The woody debris will be situated such that the future possible effects of channel scour are mitigated as much as four feet below the existing channel bottom. Native plants will be installed within the jute soil bags at the top of the stabilization structure, adjacent to the existing parking lot. As the bioengineered structure decays, revegetation within the reconstructed bank will take hold and form permanent, long-term stabilization.

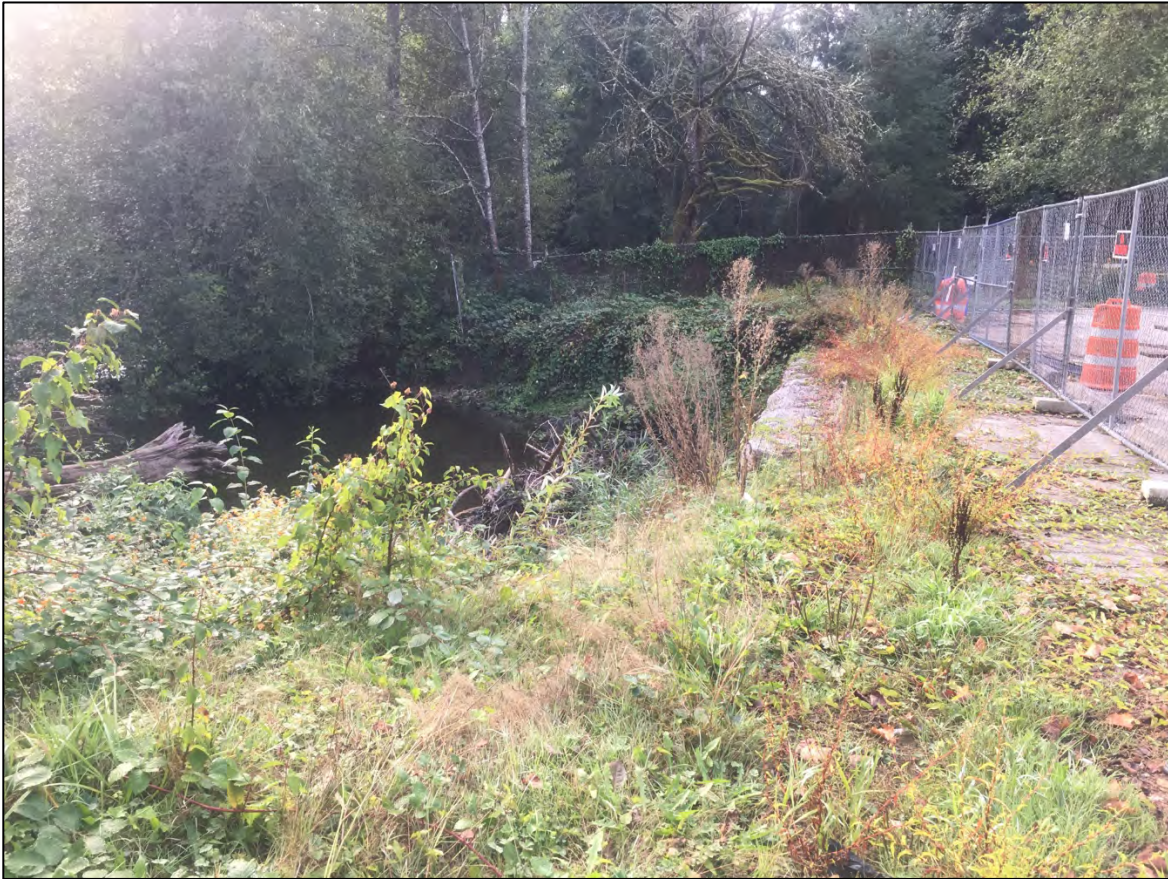
Since installing the temporary bank stabilization measures the area has partially revegetated and some woody debris (drift logs and brush) has accumulated. Vegetation in this area includes unknown grasses, bindweed (*Calystegia sp.*), reed canarygrass (*Phalaris arundinacea*), bull thistle (*Cirsium vulgare*), and Himalayan Blackberry (*Rubus armeniacus*).

Figure 7 - Existing conditions, facing south. (October 8, 2021)

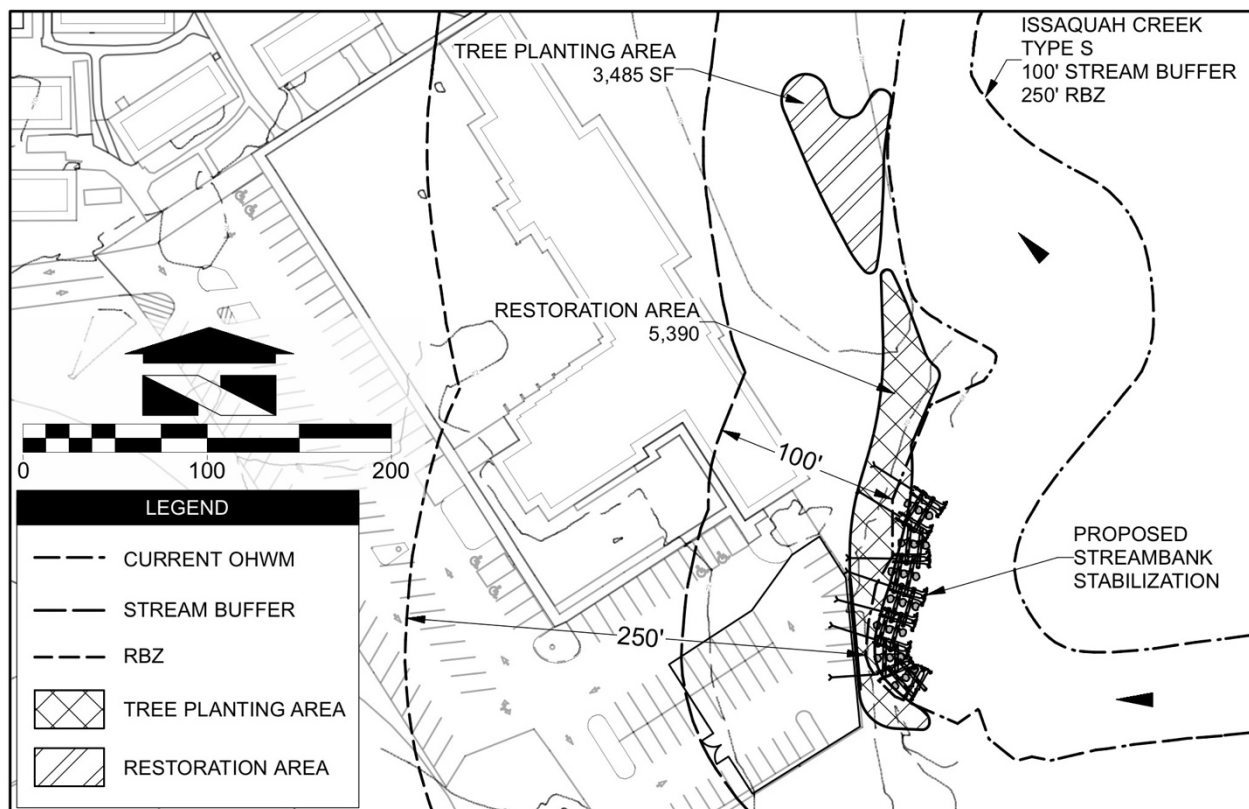
To mitigate for the removal of trees and impacts to the stream buffer and RBZ, tree replacement plantings and stream buffer restoration are proposed (see Figure 8 below). For more detailed information on critical areas and proposed mitigation please see WRI's *Critical Area Study and Buffer Mitigation Plan* for this project.

Figure 8 - Proposed mitigation areas

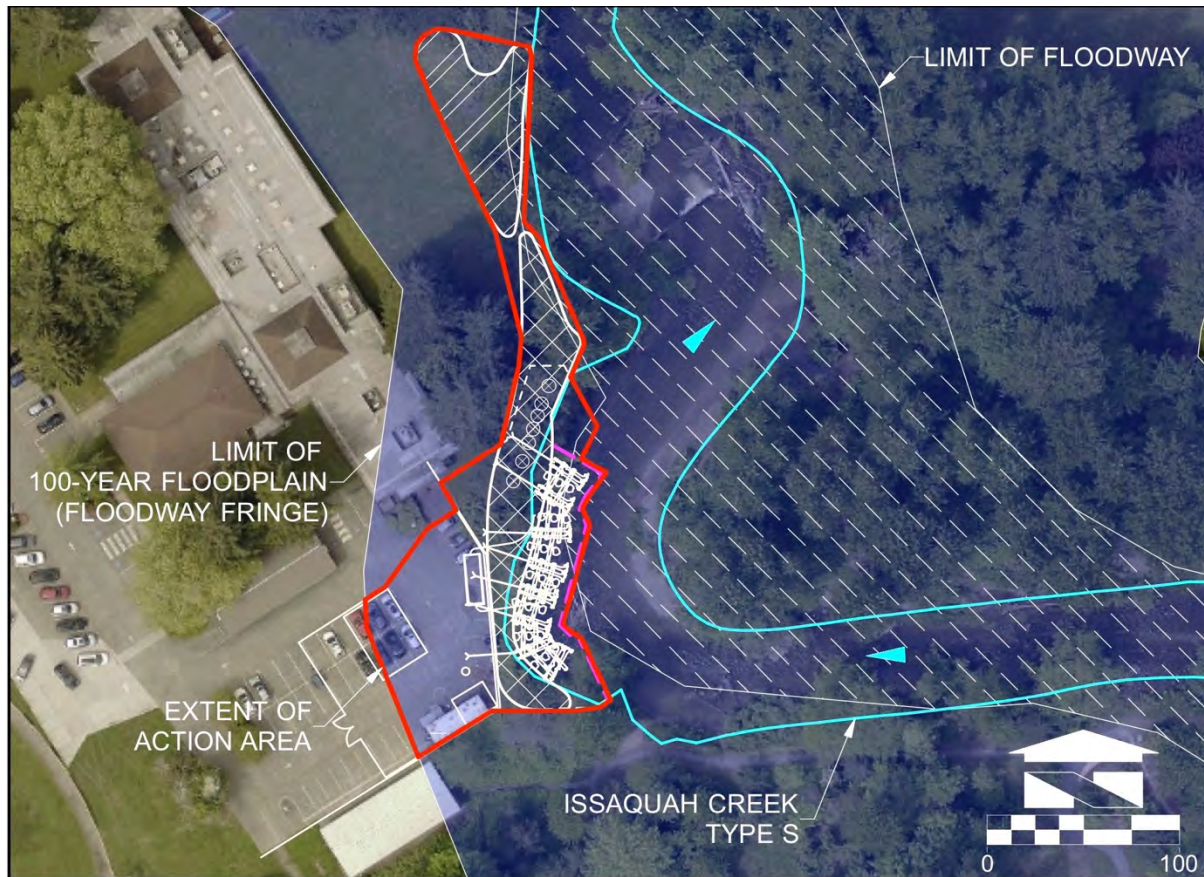
The project action area is defined by the extent of the proposed work area within the floodplain and floodway, as displayed in Figure 9 below.

Figure 9 - Project Action Area Shown in Red

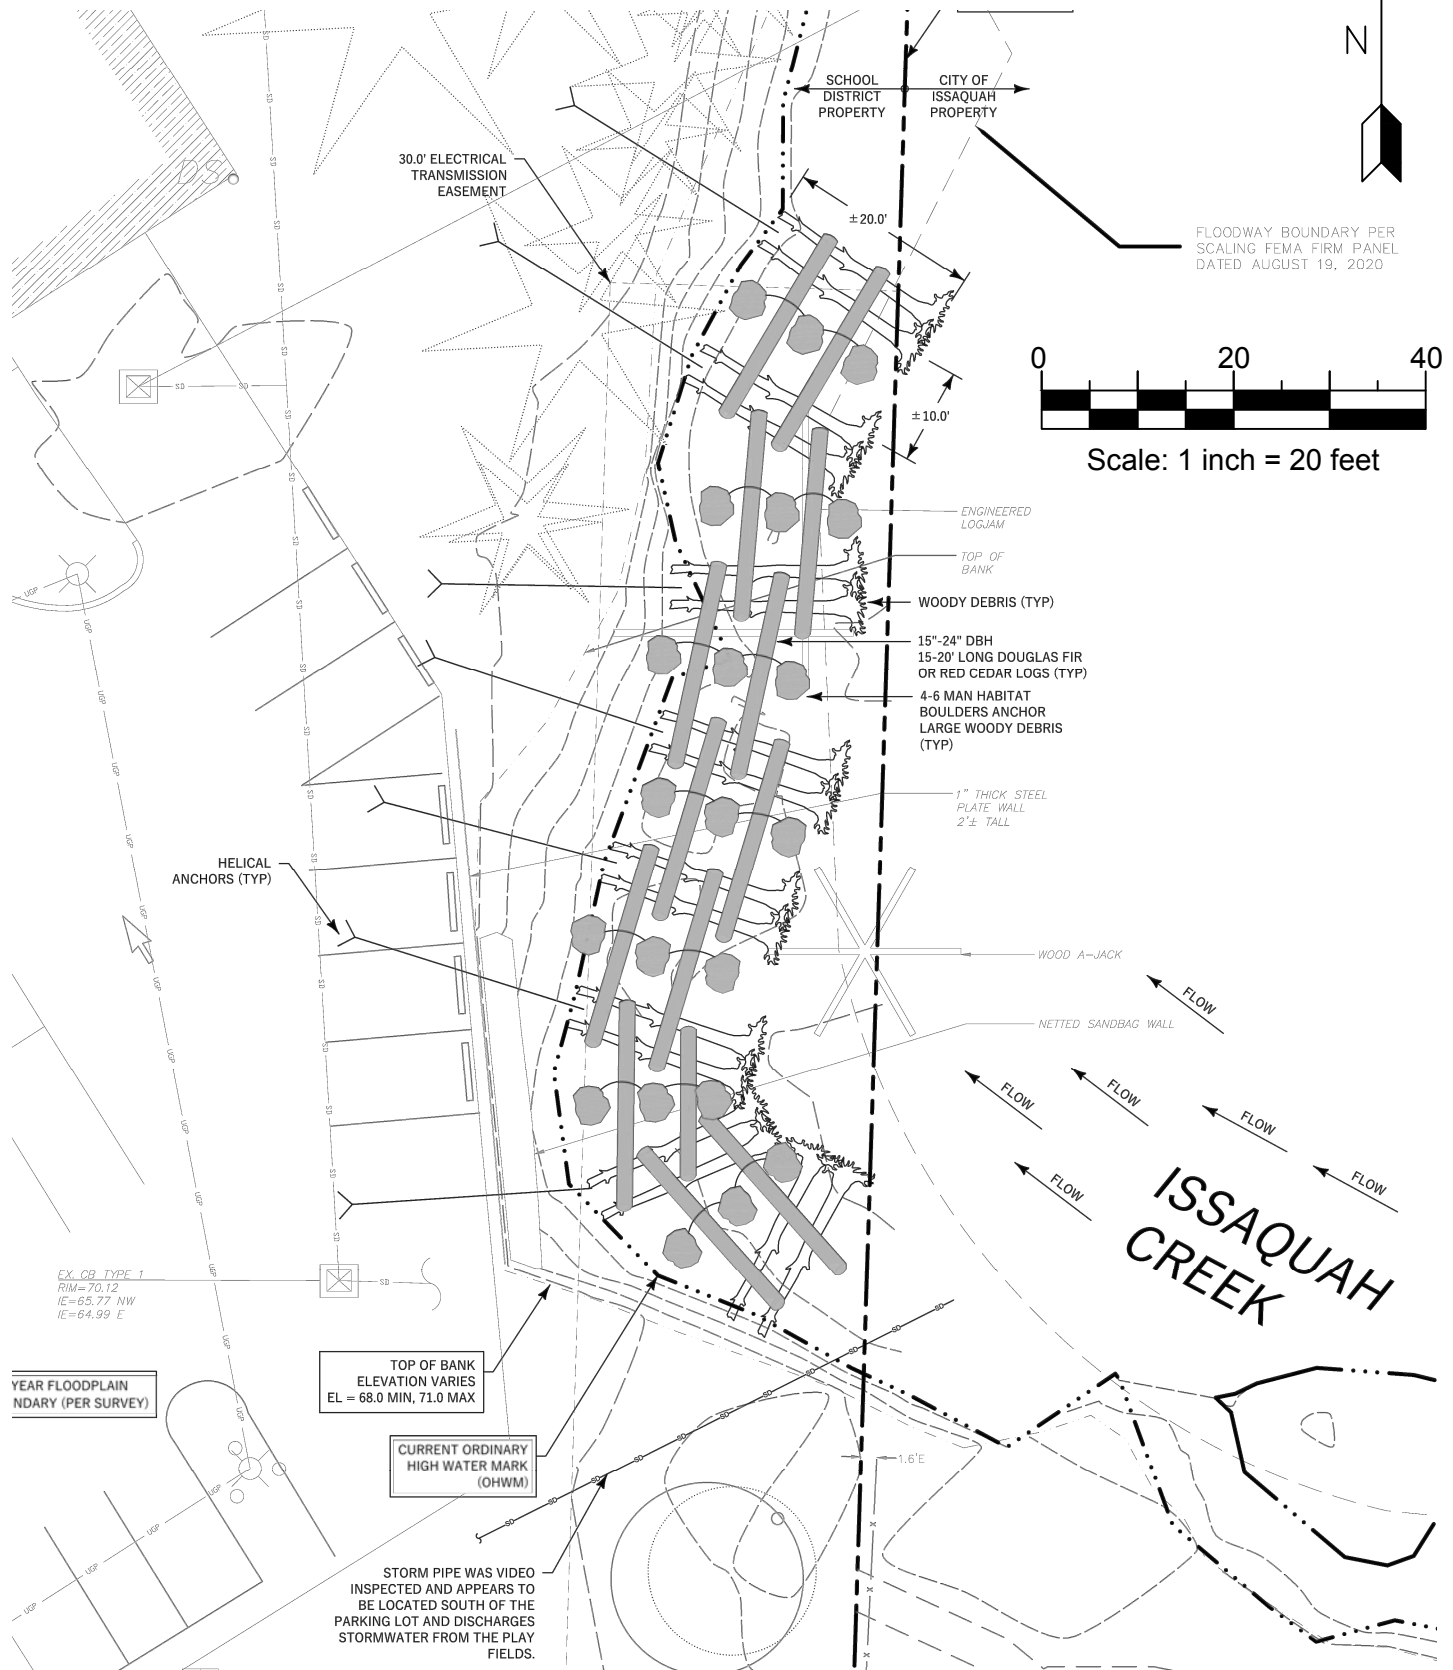
Reference: Design Plan based on a plan dated September 3, 2021 titled "IDS Holly Street Campus Permanent Creek Repair," provided by the Issaquah School District.

Project Number 1228720	Issaquah Creek Bank Stabilization Design Plan	  NELSON GEOTECHNICAL ASSOCIATES, INC Woodinville Office 17311-135th Ave. NE, A-500 Woodinville, WA 98072 (425) 486-1669 / Fax: 481-2510 www.nelsongeotech.com	Wenatchee Office 105 Palouse St Wenatchee, WA 98801 (509) 665-7696 / Fax: 665-7692	No.	Date	Revision	By	CK
Figure 9				1	9/8/21	Original	DPN	CTC

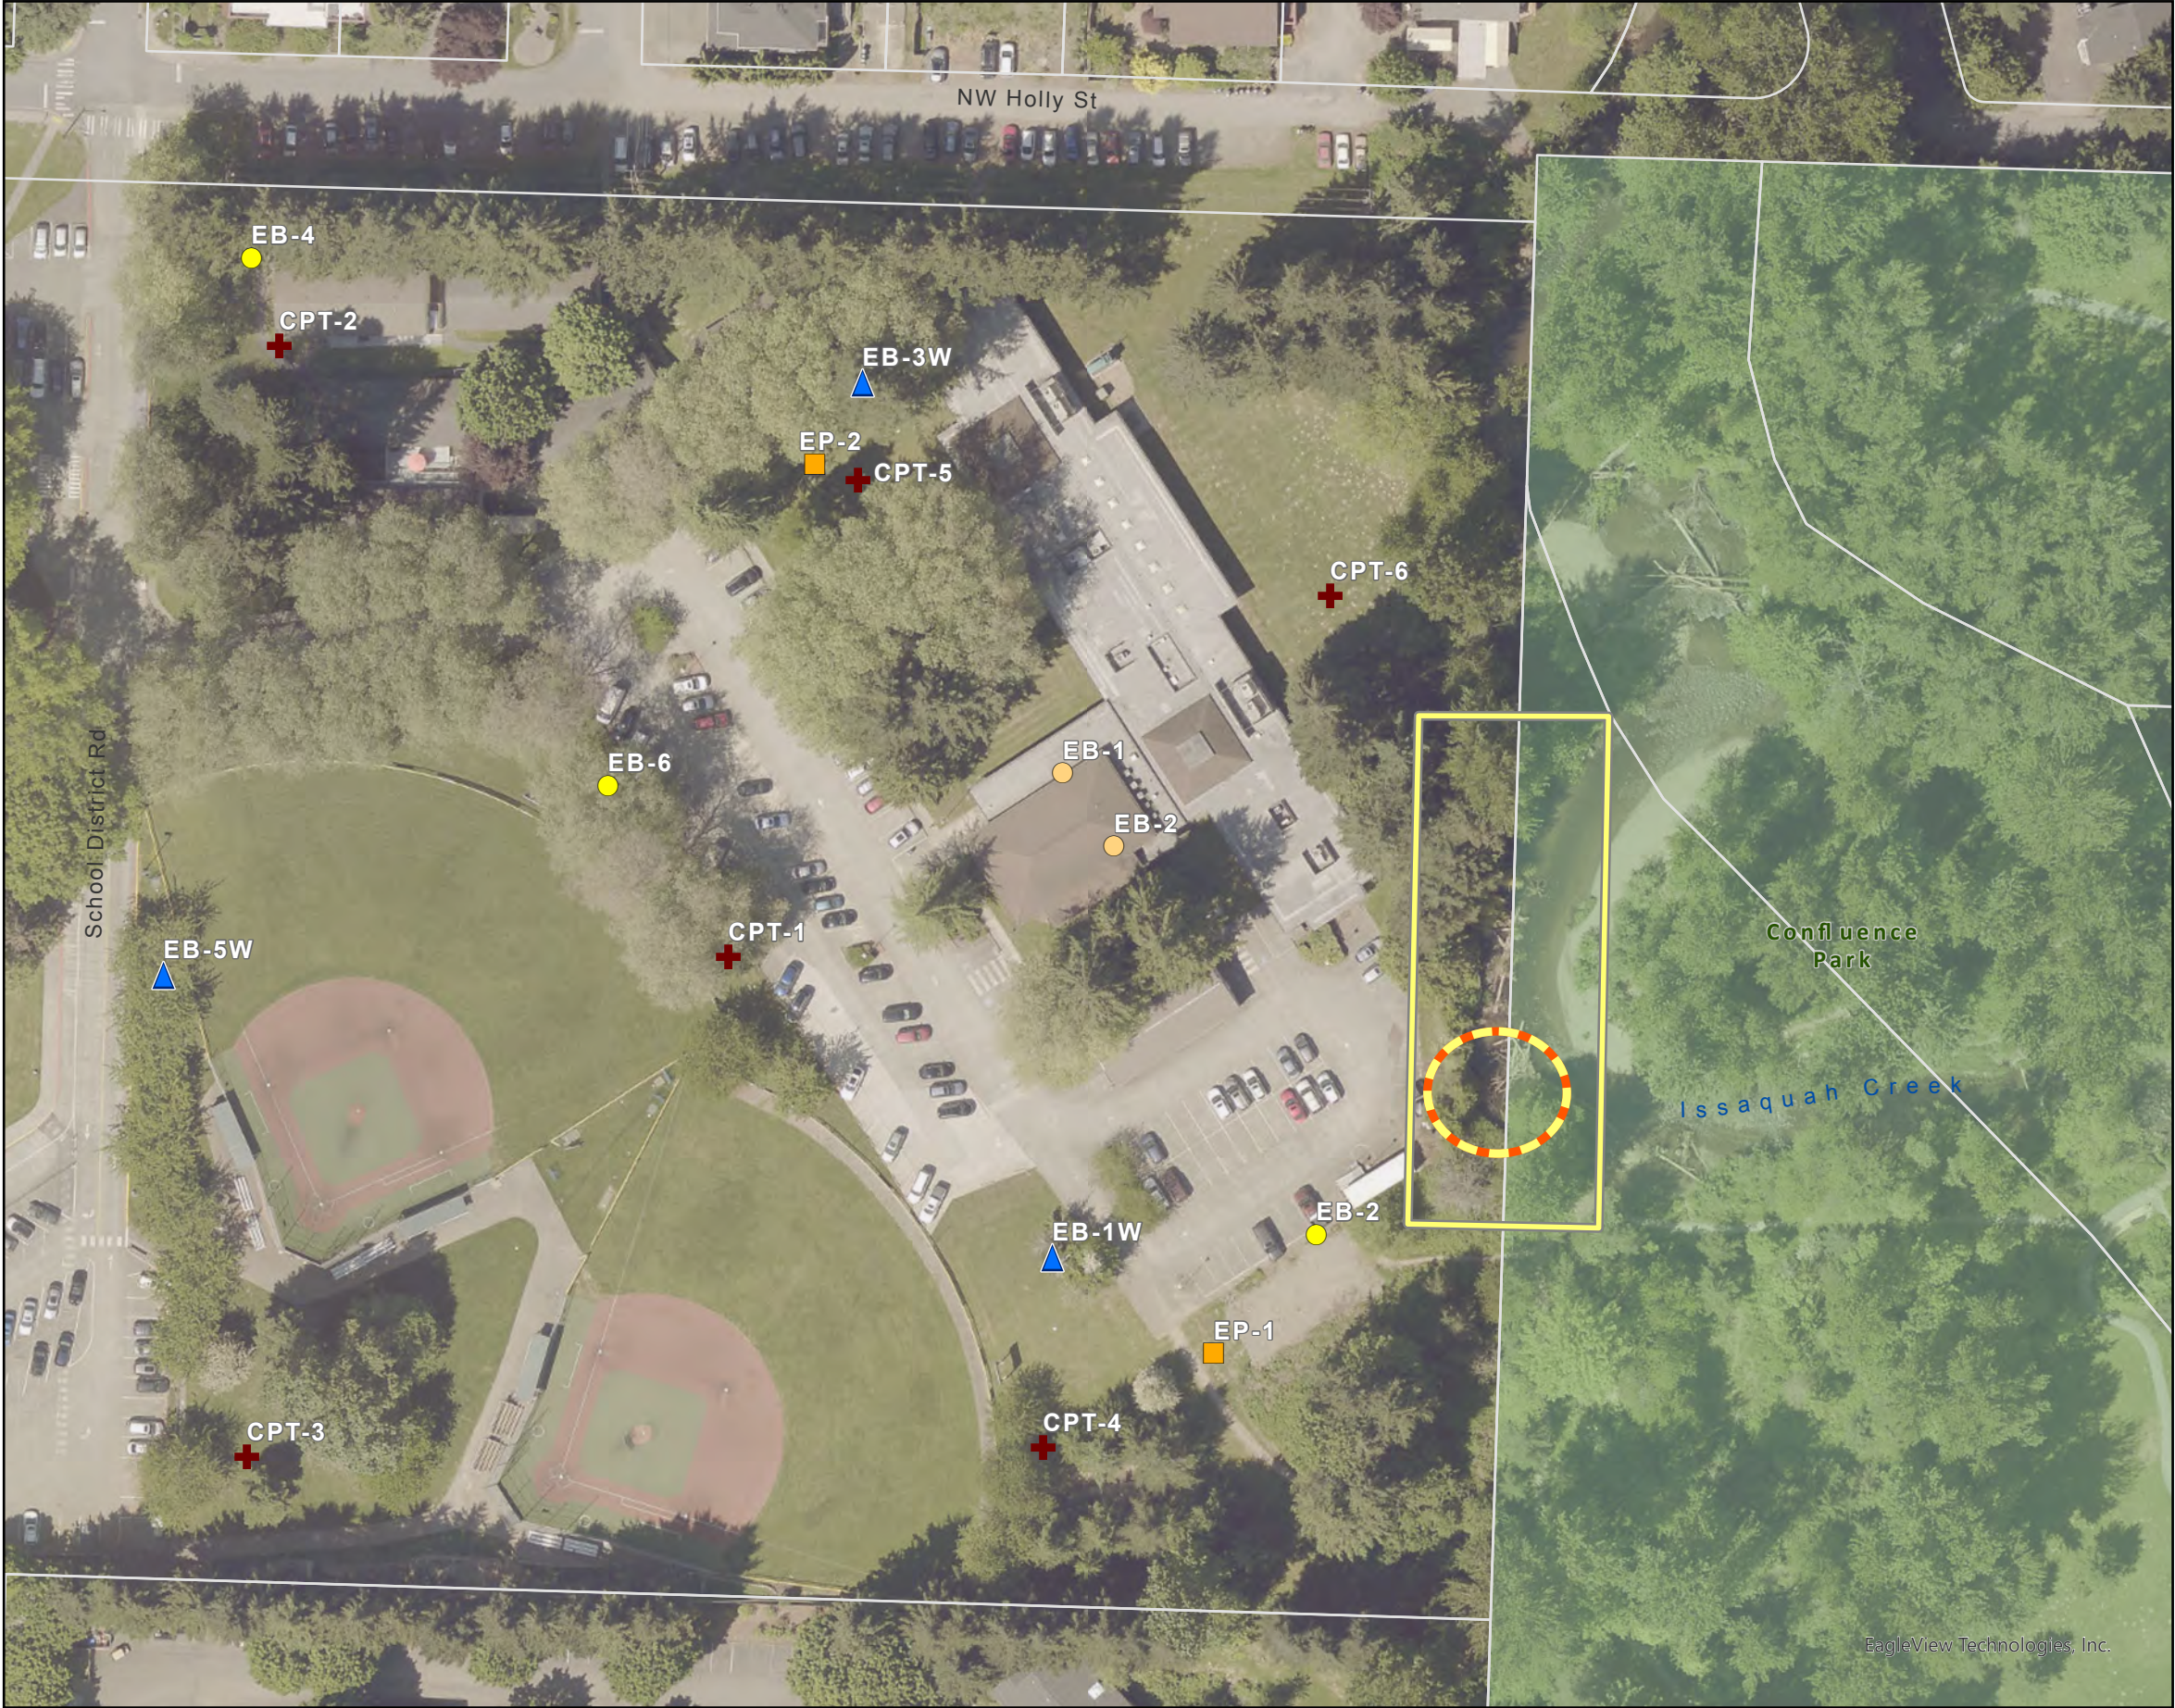
- APPROXIMATE AREA OF TEMPORARY EROSION REPAIR
- CREEK BANK EXPOSURE RESULTING FROM 2020 FLOODS
- EXPLORATION BORING (1999)
- EXPLORATION BORING (2018)
- EXPLORATION PIT (2017)
- MONITORING WELL (2018)
- CONE PENETROMETER (2018)
- PARCEL

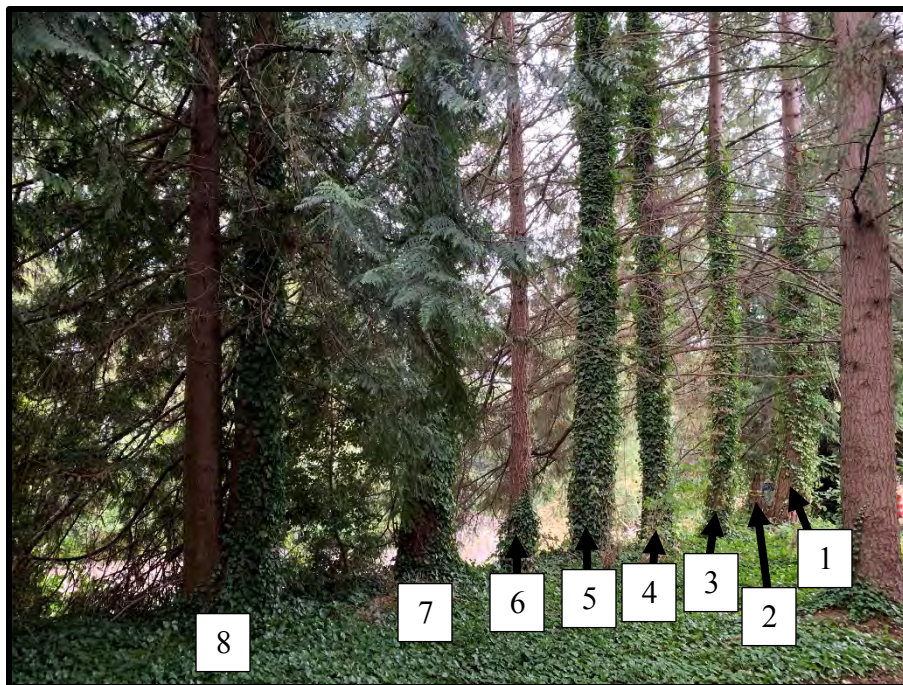
Photo 1. View of evaluated trees.

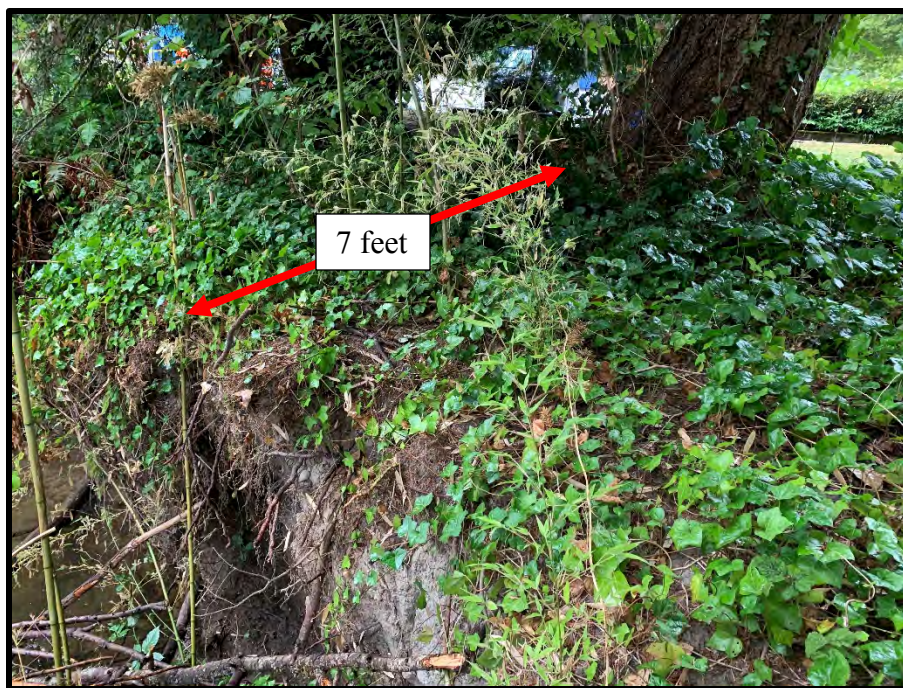
Photo 2. View of edge of bank and Tree #2.

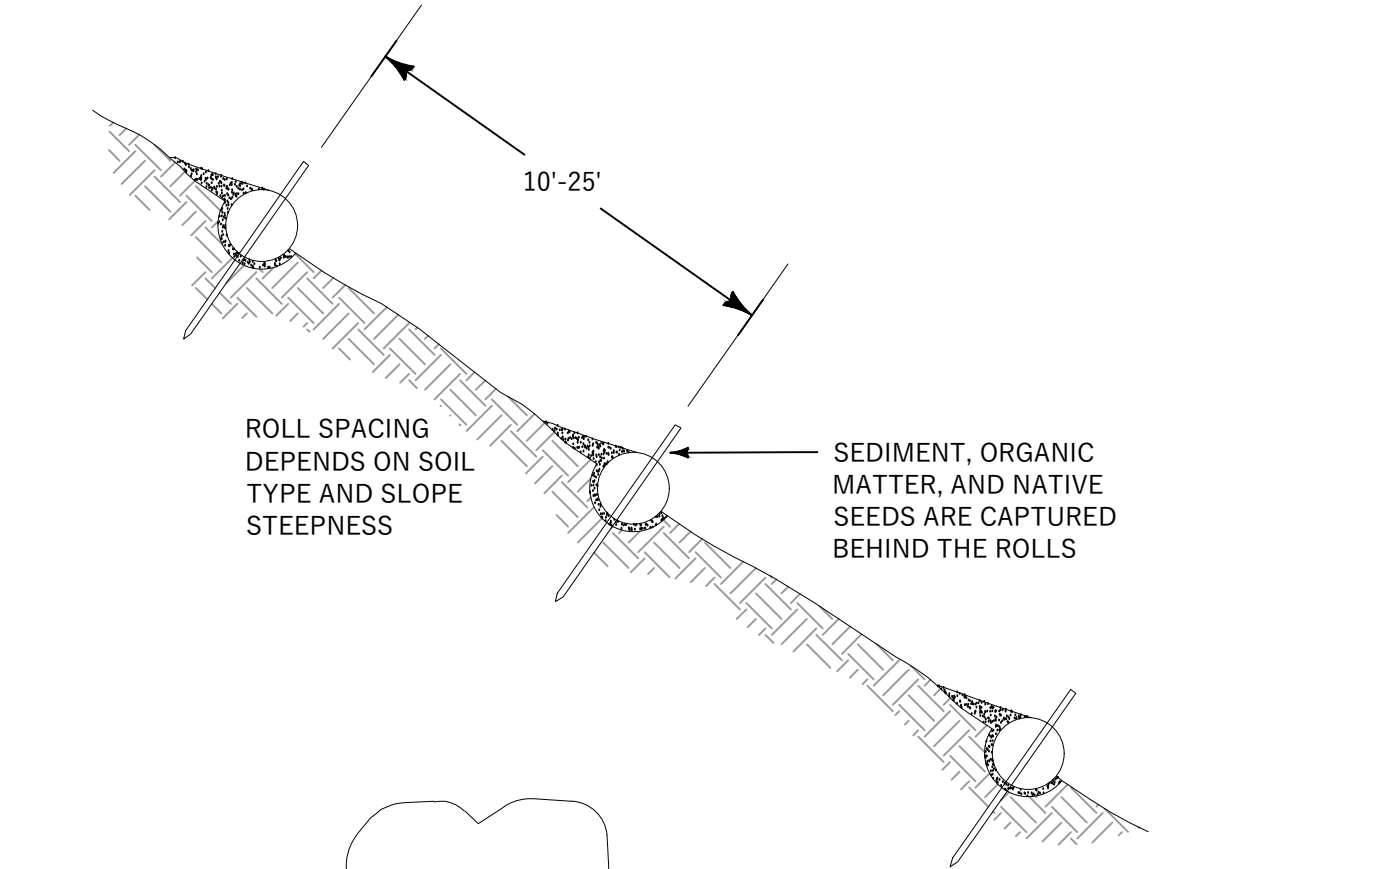
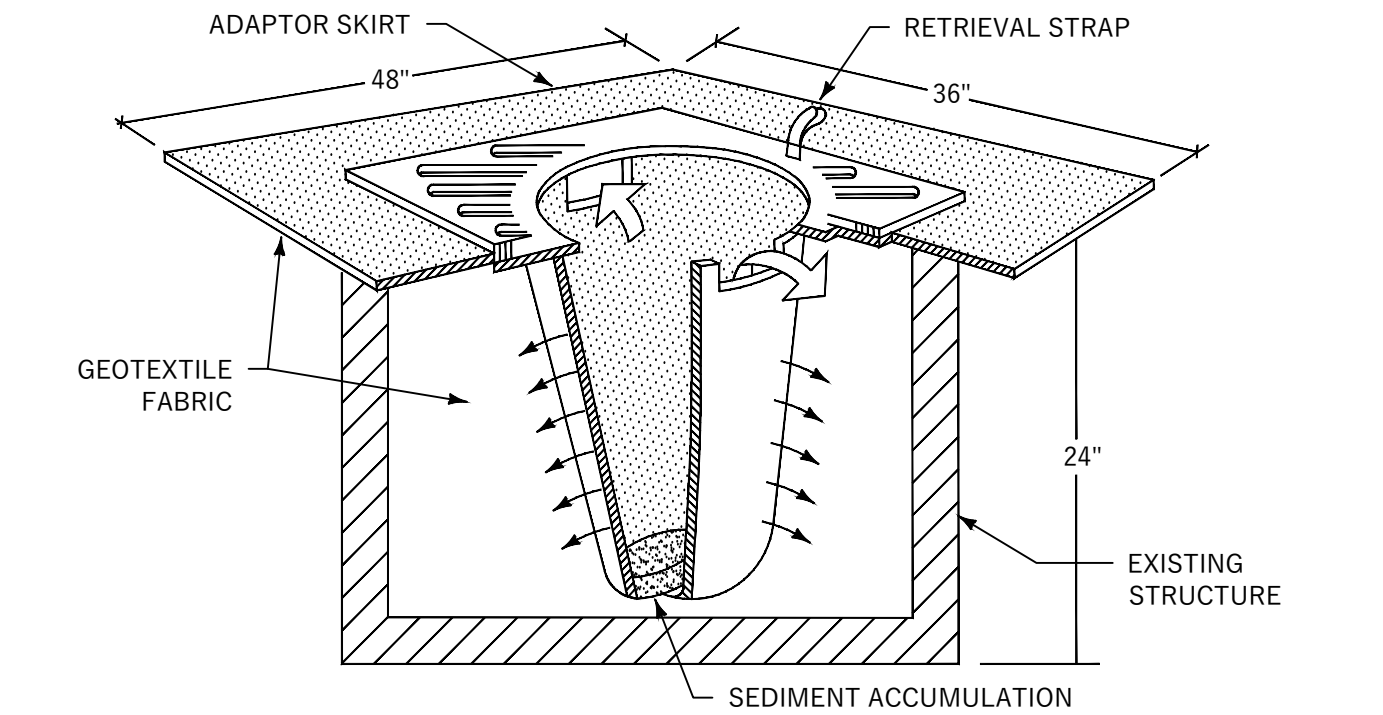
NOTES:
1. FILTERS SHALL BE INSPECTED AFTER EACH STORM EVENT AND CLEANED OR REPLACED WHEN 1/3 FULL.
2. INSTALL INLET PROECTION IN ALL NEW STORM STRUCTURES THAT WILL COLLECT STORMWATER AS THEY ARE INSTALLED.

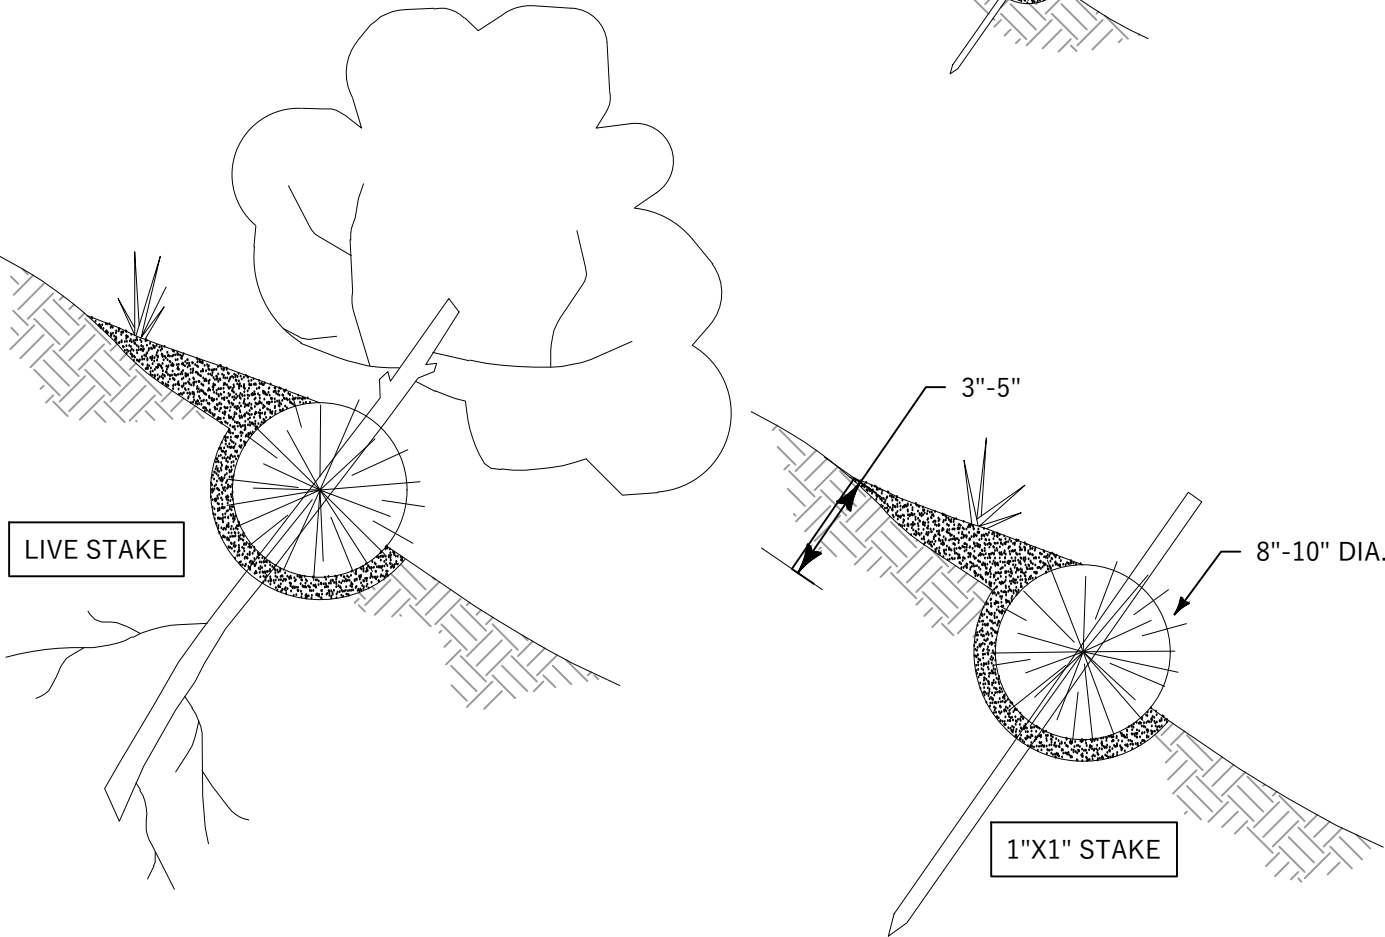
NOTES:
1. FILTERS STRAW ROLL INSTALLATION REQUIRES THE PLACEMENT AND SECURE STAKING OF THE ROLL IN A TRENCH, 3" X 5" (75-125MM) DEEP, DUG ON CONTOUR.
2. RUNOFF MUST NOT BE ALLOWED TO RUN UNDER OR AROUND ROLL.
